Response to Recommended Preferred Route Corridor and Possible Route Options – March 2021 – A83 Access to Argyll and Bute

The Topographical Setting

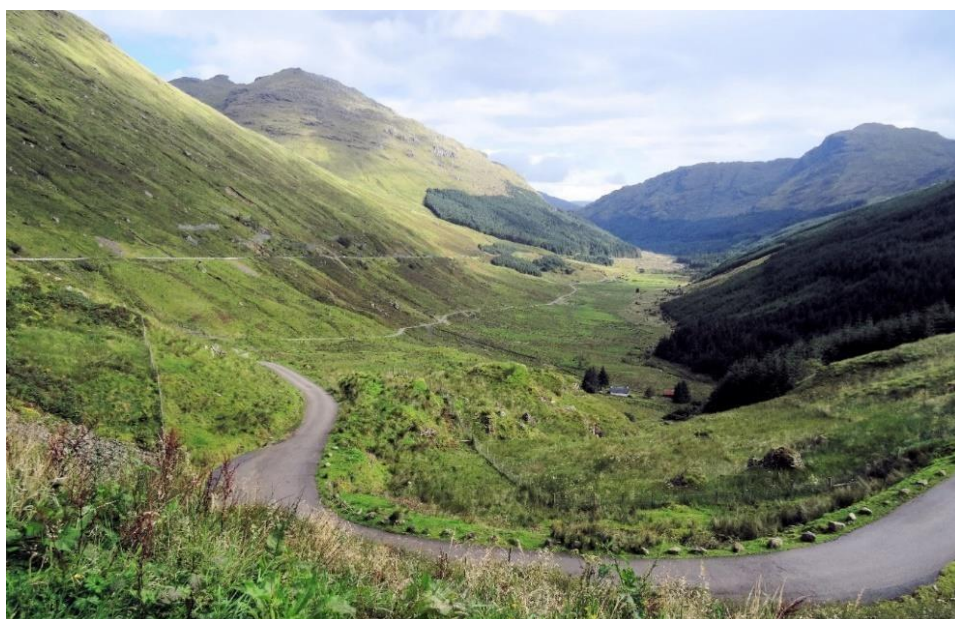
Fig. 1 Glen Croe from the view point at the NW summit

Glen Croe is a glacial valley with an asymmetrical profile. The NE slopes (left hand side of fig. 1) rise steeply to the summit of Beinn Luibhean (859 m, Fig. 2) in a horizontal distance of 1.25 km; the heavily wooded ground on the opposite side of the glen ground rises somewhat less steeply towards gentler slopes above the tree line before rising again more steeply towards the summit ridge of Coire Culach (660 m) and the distant Ben Donich (847 m.) more than 2.4 km to the SW.

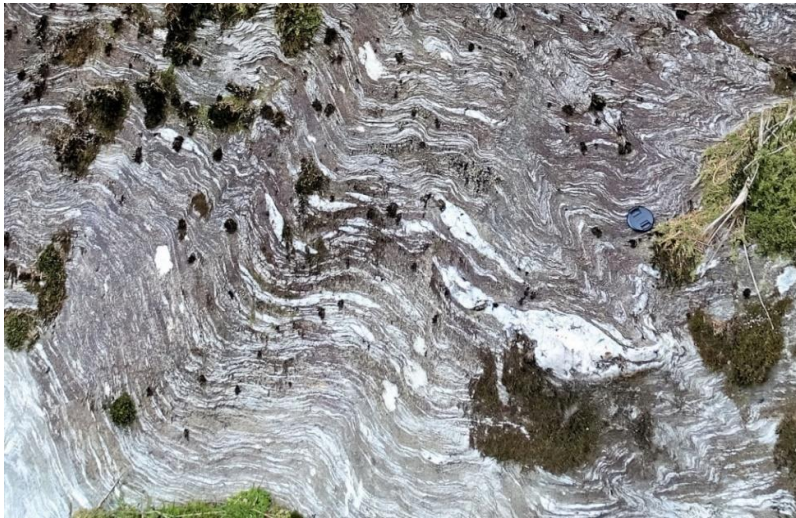
Fig. 5. Deformed mica schist exposed in a cutting of the forestry road close to the junction with the Old Military Road in Glen Croe [NN 24458 04767]. Note the white vein quartz, deposited from aqueous fluids in areas of low stress during in homogeneous shearing stress (the diameter of lens cap scale 56 mm).

micaceous crystals (fig. 5). The scale and intensity of deformation of the Beinn Bheula Schists is highly variable due to the contrasting lithologies of the resistant beds of the quartzose schists (fig.6) and the more easily deformed mica schists.

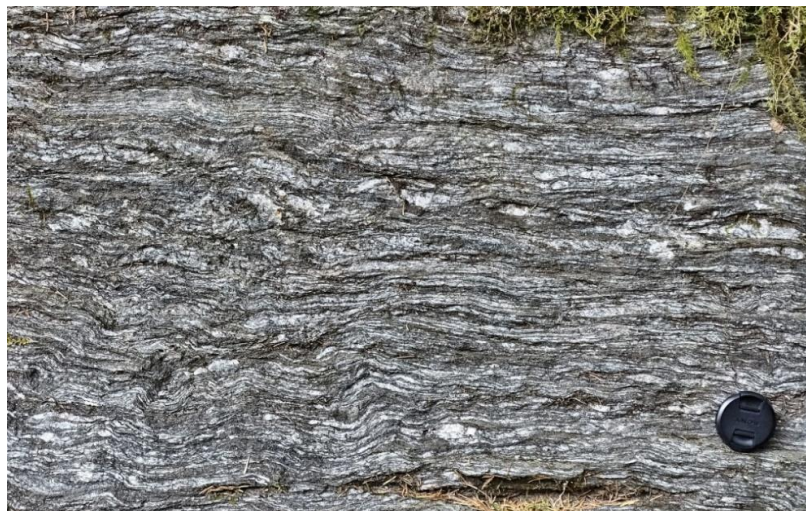
Fig.6. Quartzose schist cropping out beside the forest road [NN 23922 05413] about 1 km NNW of fig. 5. The lithology of this rock is dominated by quartz, subordinate feldspar and a smaller proportion of chlorite. The protolith of this rock would have been a poorly sorted coarse-grained muddy sandstone.

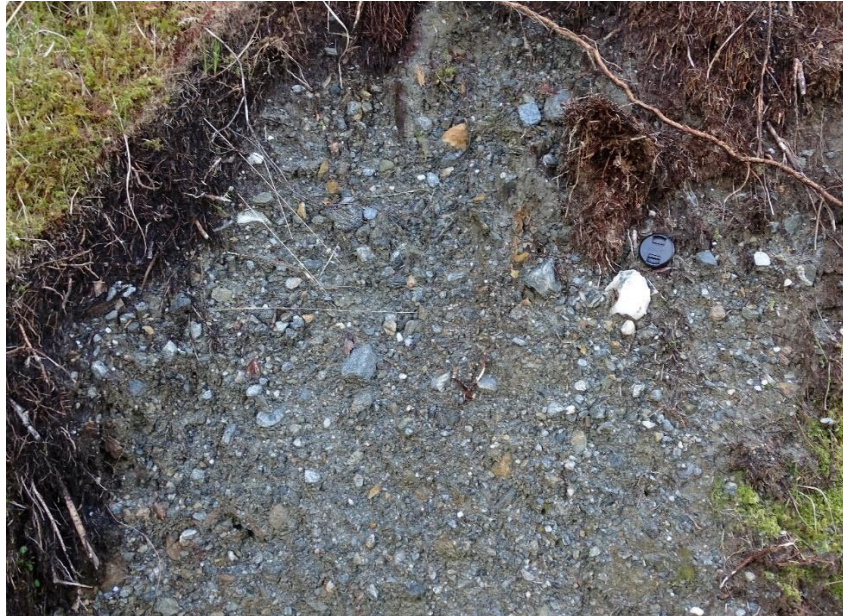
Fig. 7. Unconsolidated drift at the side of the forestry road [NN 24181 05089]: typical diamictite with a wide range of sizes and compositions of clasts. Note the large, angular fragment of white vein quartz beside the lens cap (diameter 56 mm) and the somewhat smaller clasts of metagreywacke.

The slopes on both sides of Glen Croe are mantled by varying thickness of drift composed of varying proportions of regolith (loosely bound residual material produced by weathering of the bedrock), glaciogenic sediments and debris that has slipped down the slopes. Boulders of various sizes are perched on the slopes. They include fragments of bedrock (fig. 7) and erratics of various compositions and origins transported there by glacial action.

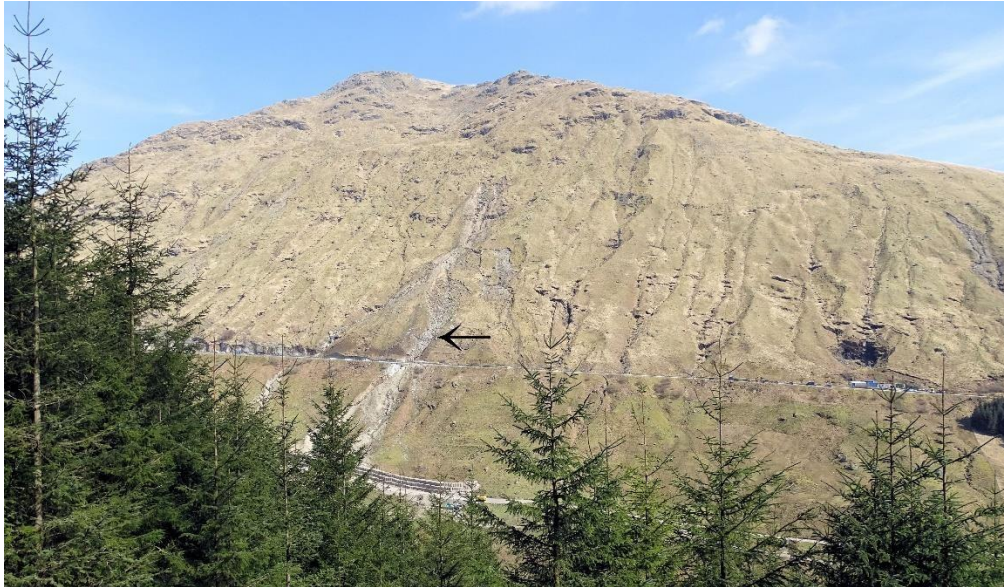
Fig. 8. The slopes of Beinn Leubhean above the A73(T) in Glen Croe. Note the scar (see arrow) left by a recent landslide that closed both the main road and the Old Military Road. There is a risk of further landslips across the entire width illustrated, but especially from the slopes on the left-hand half side of the photograph.

1. It needs to be emphasised that the whole of the section of the A83(T) as illustrated in fig. 8 is at risk from further debris flows. The risk is particularly significant in the

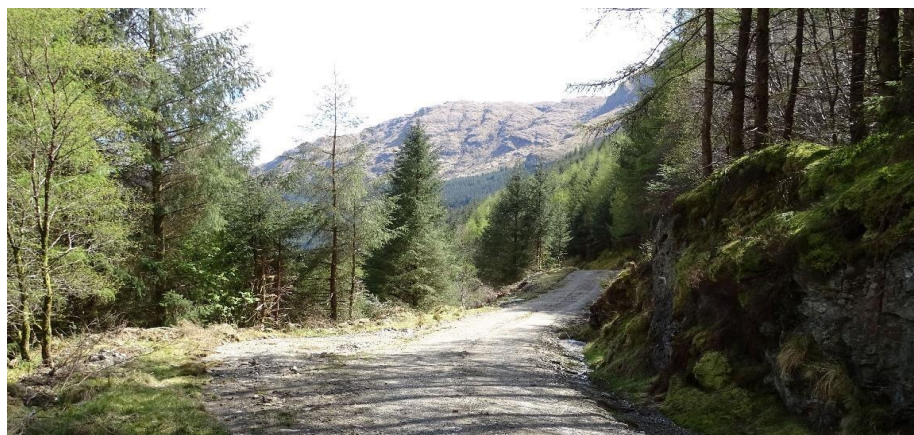
Fig. 9. Forestry road at an altitude of about 200 m. on line of section C – D (figs 2 & 4)

Access to the forest is already provided by a set of well-constructed dirt roads. This affords the opportunity to examine what effect they have had on slope stability. One such road (fig.9) is accessible from close to the southern end of the Old Military Road; it ascends from an altitude of about 100 m above mean sea level to about 280 m near the NW end of the glen. This road is wide enough to accommodate the large vehicles used to transport timber and there are a number of passing places.

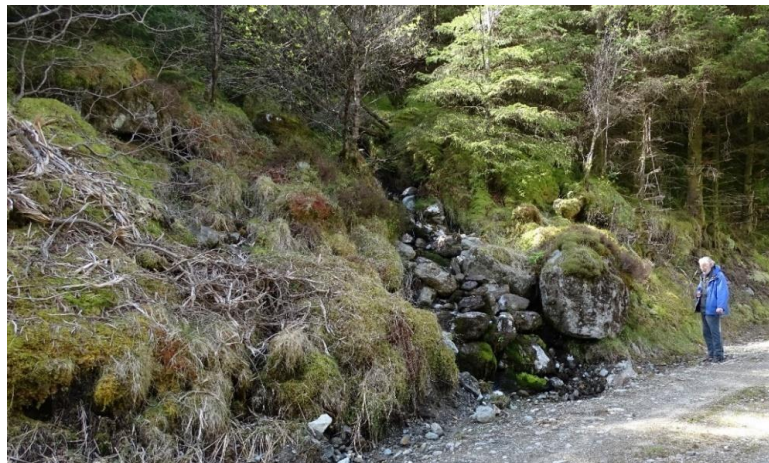
Fig. 10. Boulder trail in a gully beside the lower reaches of the forestry road. The trail extends some metres to the left of the exposed boulders but is obscured by a thick mantle of mossy vegetation

- iii) Above 150 m the forestry road does not intersect major drainage channels but at lower altitudes there exist a number of boulder-choked gullies (Fig. 10). This reflects the extent of the catchment areas to the SW of the road. The catchment of the upper reaches of the road is limited by the position of the Coire Culach ridge; at lower levels gullies are fed by the much more extensive catchment situated between the road and Ben Donich. Nevertheless, the ground, up-slope from the lower end of the road, appears to be no less stable. The gullies, while channelling a greater volume of water, do not appear to be eroding the ground between them and the boulders show little evidence of instability. From their size it appears likely they were transported to their present positions at the time of last retreat of the ice when deglaciation took place some ten thousand years or so ago leading to a short episode of greatly enhanced flow of meltwater. Major excavation of the hillside has to take into account the danger that some of these boulder trails could collapse; it would be prudent to consider what localised remediation measures might be required.

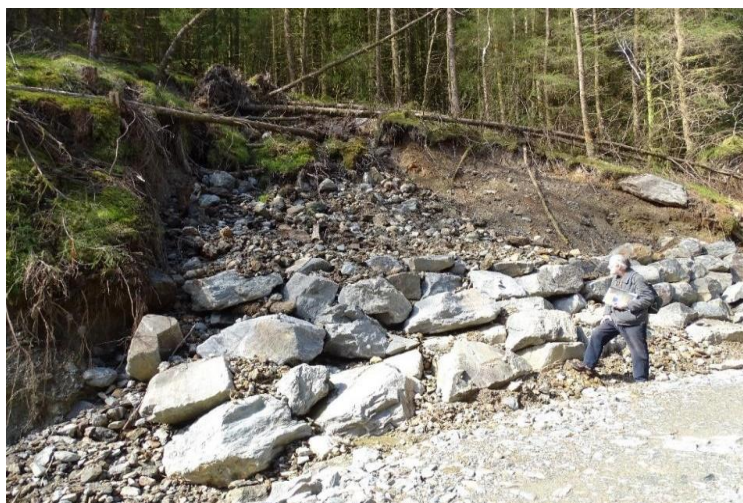
Fig. 11. Rare collapse of an unusually thick deposit of unconsolidated drift. The large boulders were placed to protect the road from any further slippage.

- iv) The only obvious sign of recent instability of unconsolidated drift on the up-slope side of the road is where an unusually thick layer of unconsolidated drift has collapsed (fig. 11).

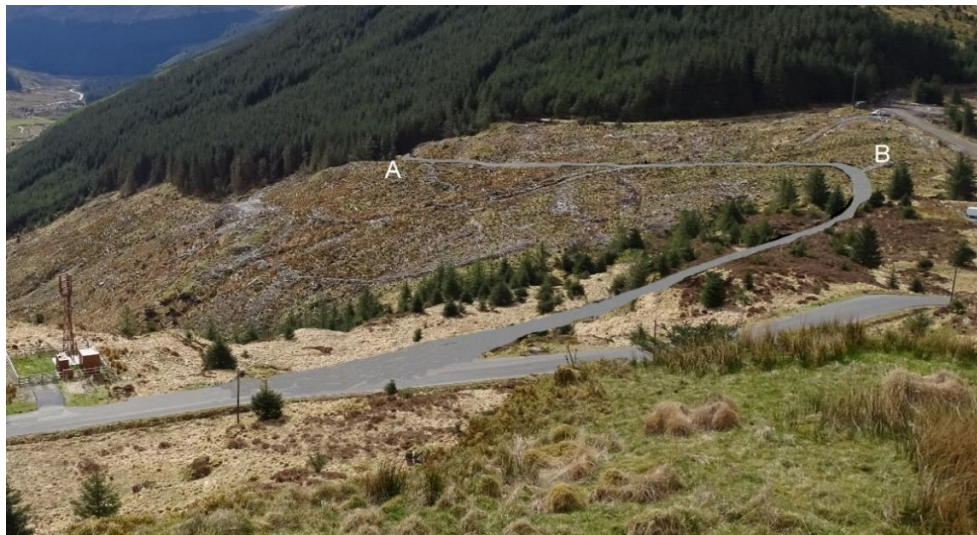
Fig. 12. View from a knoll [NN 22890 07220] overlooking the B828, 240 m. SW of the junction with the A83(T) at the Rest and be Thankful. A possible route for the upper end of a new road up the SW side of Glen Croe, is pasted in. The new road would enter the forest at a bench in the slope at A, some tens of metres below the forest road. A safer connection with the B828 could perhaps be made at a junction near B.
